Case Report :

Recurrence at the hepaticojejunostomy (HJ) site

신지훈 Dr.
Dr. Shin Ji-Hun

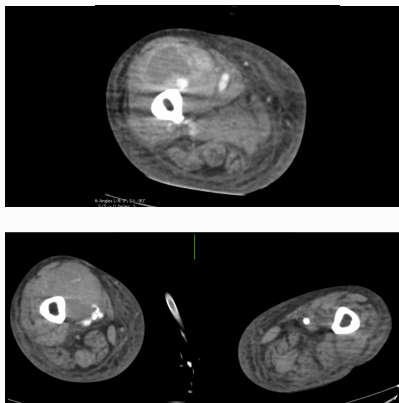
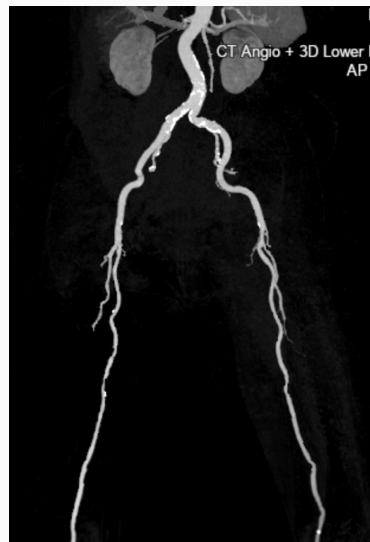
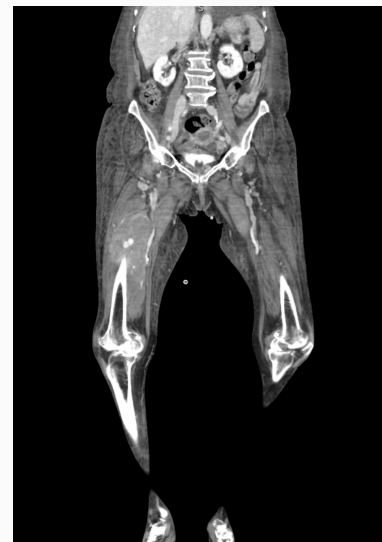
Pre-Treatment CT Imaging

Large hematoma in right thigh
Contrast leakage in the hematoma → Pseudoaneurysm
Diffuse swelling in pelvis and right thigh
Pleural effusion in both

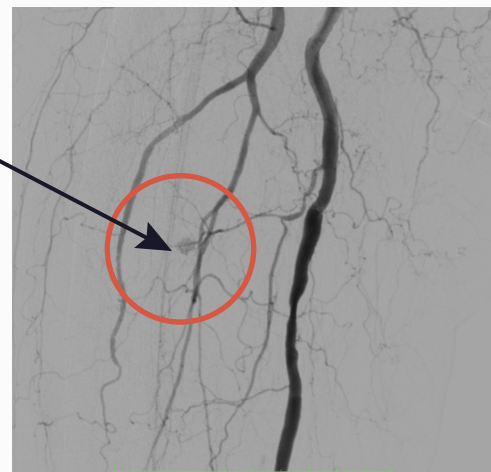
Fig4

Angiographic finding
Small pseudoaneurysm in right thigh in small branch from superficial femoral artery (perforating artery)

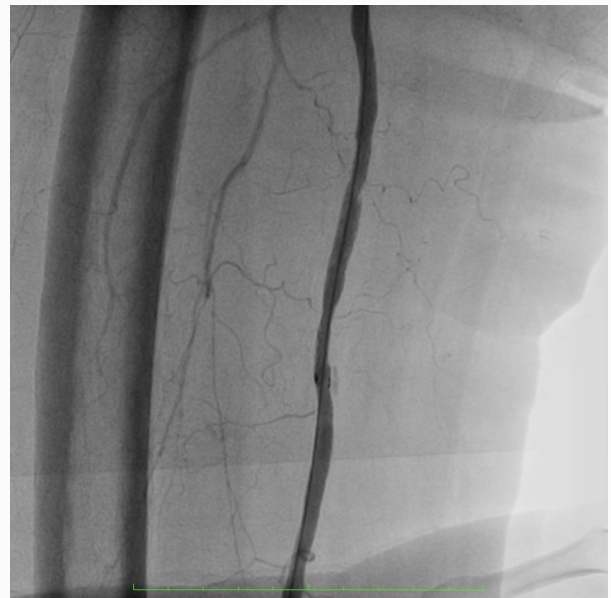
After e-PTFE stent graft placement, contrast leakage was not detected.

Selective superficial femoral arteriography showed small contrast leakage from branch vessel of superficial femoral artery

- E-PTFE stent graft (S&G Biotech Inc. Yongin, Korea)
- 8mm 6cm
- 6mm PTA balloon catheter
